State of California
The Resources Agency
DEPARTMENT OF WATER RESOURCES
Division of Flood Management

**SEPTEMBER
2002
OFFICE REPORT**

**THE INSPECTION OF FLOOD CONTROL STRUCTURES
ON THE SACRAMENTO AND SAN JOAQUIN RIVERS
AND THEIR TRIBUTARIES**

**Prepared By The
Flood Operations Branch
FLOOD PROJECT INSPECTION SECTION**

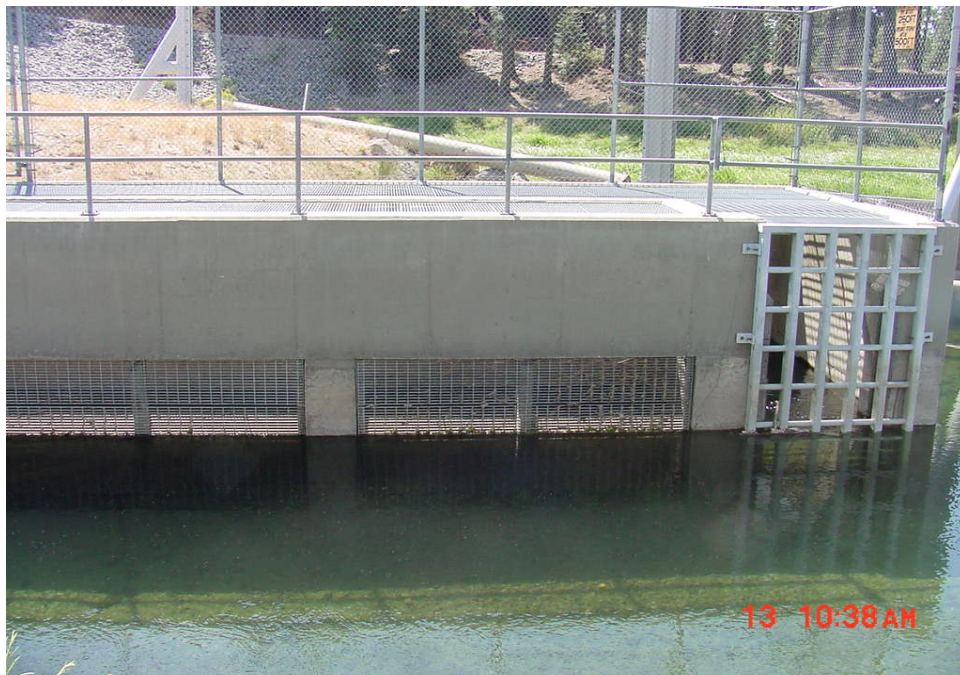
Steel trash racks.

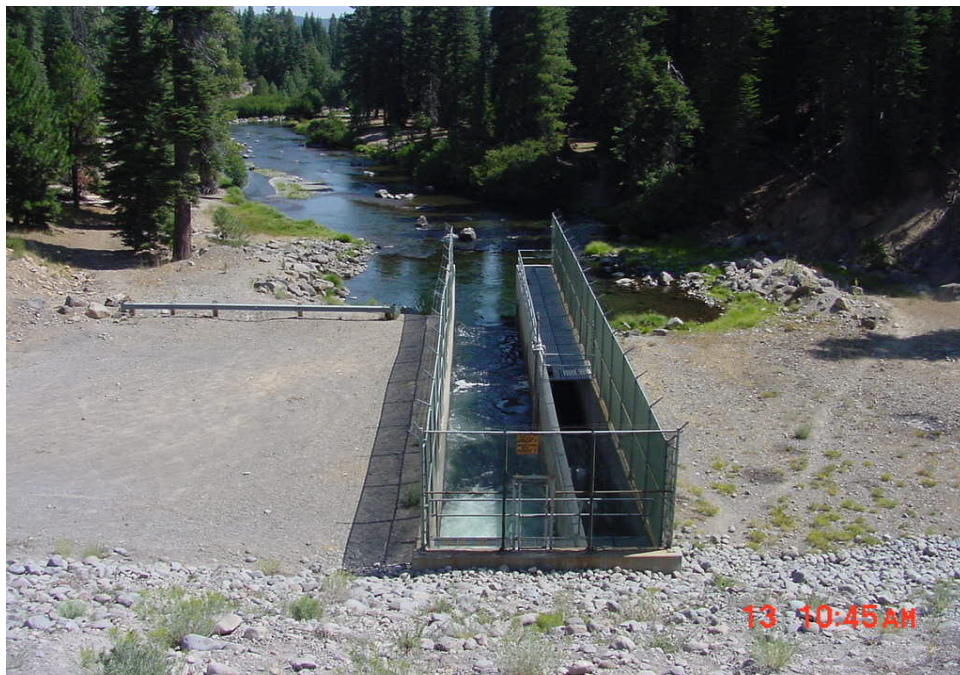
**Downstream at the outlet works.
Note open gate.**

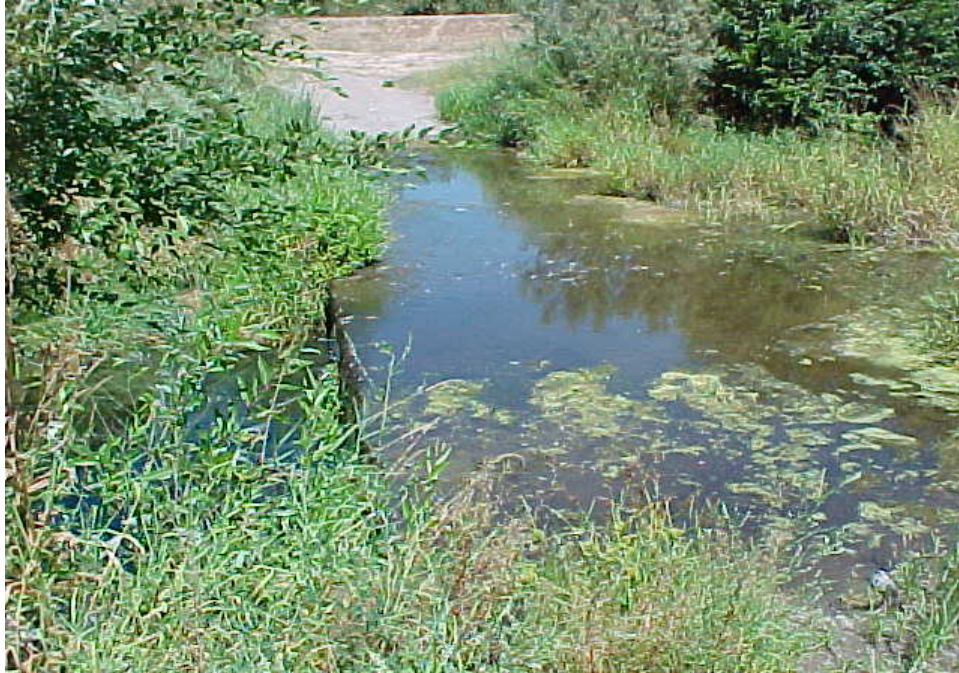
1. Condition of concrete weir structure.
 - a. Good, but ineffective due to accumulation of gravel upstream of the structure.
2. Condition of the diversion structure and wing walls.

**Water flowing over the concrete weir.
Weir is ineffective due to gravel build-up upstream.**

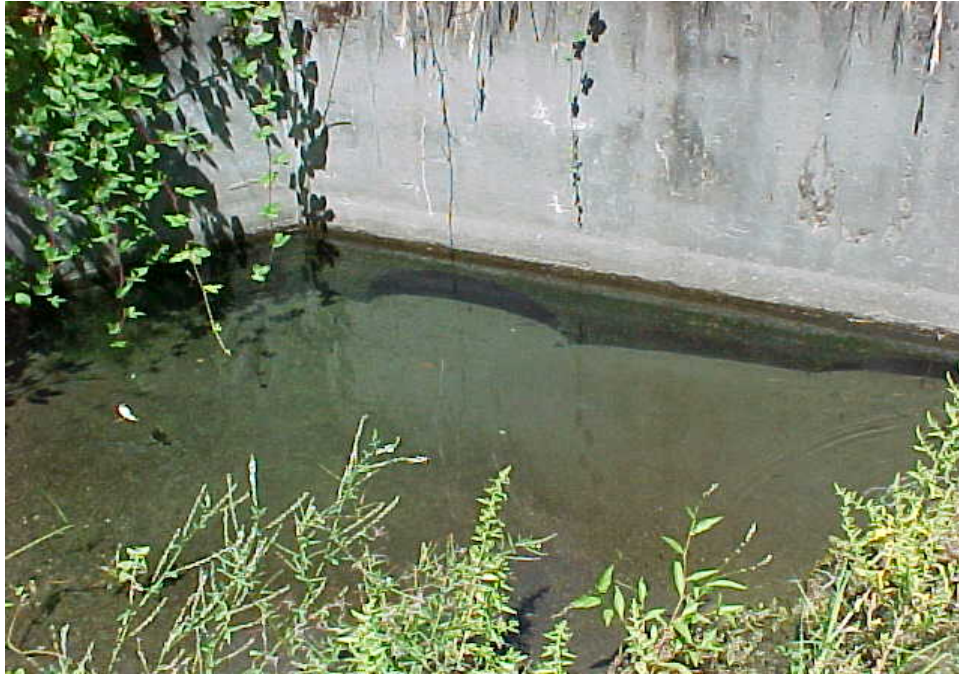
- a. Good, but pipes are three quarters full of sand.
3. Condition of the bulkhead.
 - a. Good.
4. Condition of the control gates and mechanism.
 - a. Good.

**Two of the six, 36 inch discharge
pipes at the outlet side of diversion structure.
These pipes are nearly full of sediment.**

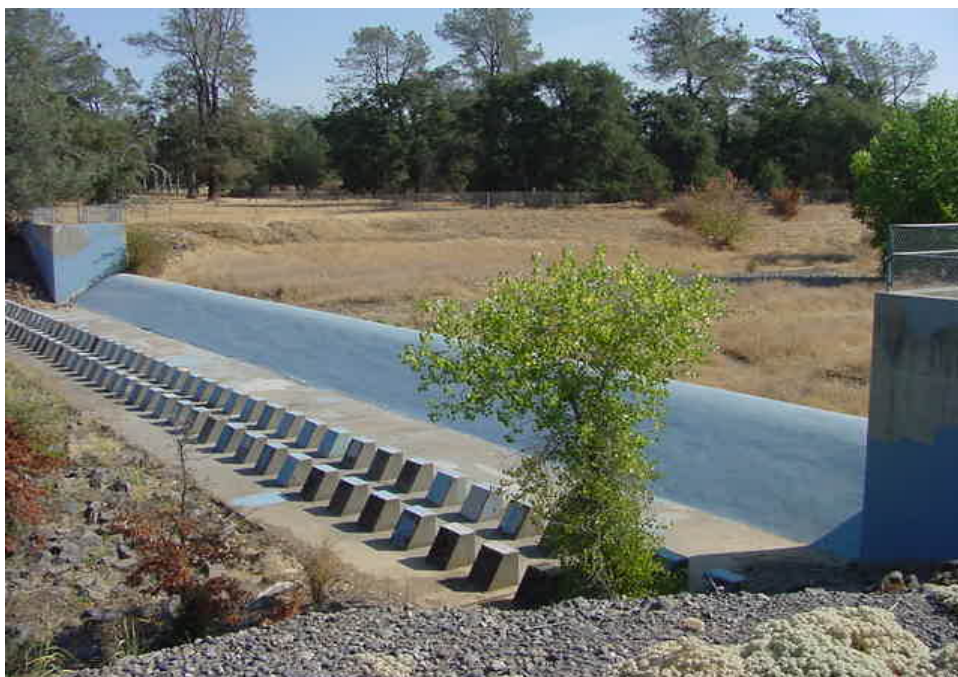
- 1. Condition of concrete weir structure and stilling basin, and velocity dissipaters.**
 - a. There are minor joint separations on the north and south ends of the weir where it contacts the abutments.**
 - b. There is minor damage to several velocity dissipaters and severe damage to one.**
- 2. Condition of concrete abutments and wing walls.**
 - a. Good.**
- 3. Condition of revetment.**
 - a. Good.**
- 4. Accumulation of trash and debris around the structure or in the channel.**
 - a. None.**
- 5. Vegetation around structure or in the channel.**
 - a. Minimal.**
- 6. Condition of gauging house and equipment.**
 - a. Fair.**
- 7. Comments:**
 - a. Repair the severely damaged velocity dissipater. This was first noted in the 2000 Structure Report but has not been repaired.**
 - b. Remove vegetation from channel.**
 - c. Fair maintenance.**

**The velocity dissipaters on the downstream side
of structure from the left bank.**

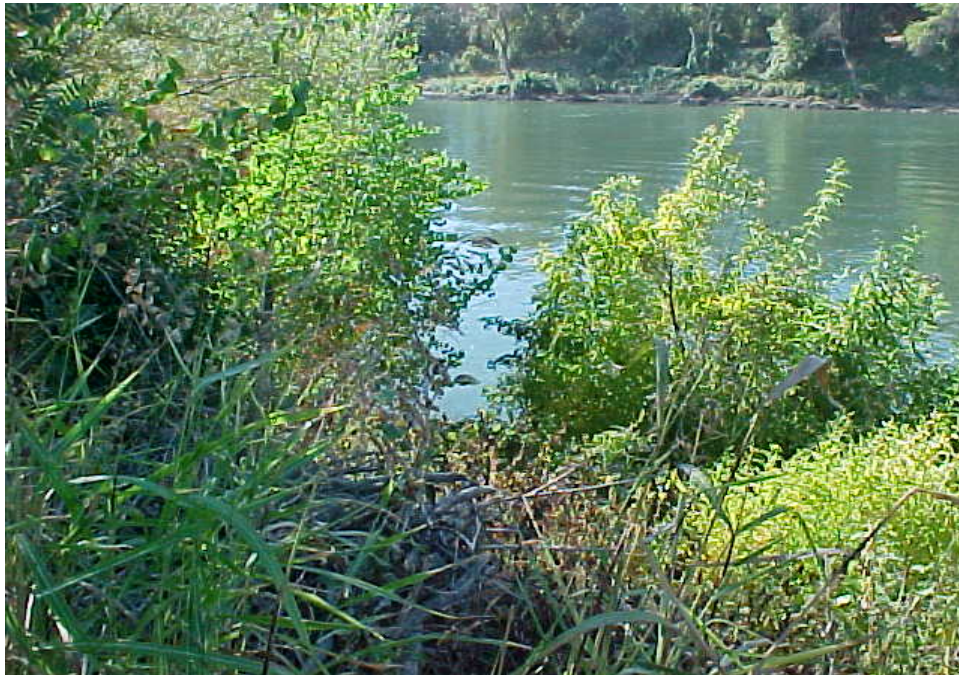
1. Condition of the corrugated metal pipe (CMP) drainage structure.
 - a. Good.
2. Condition of the control gate, mechanisms, and flap gates.
 - a. Could not properly inspect due to excessive vegetation.
3. Condition of the revetment.
 - a. Good.
4. Accumulation of trash and debris around the inlet, in the pipe or in the channel.
 - a. Could not properly inspect due to excessive vegetation.
5. Vegetation around the structure or in the channel.
 - a. Heavy vegetation around structure. Growth is so dense that intake and discharge ends of structure cannot be seen.
6. Comments:
 - a. Remove vegetation from inlet and discharge ends of structure. If growth is not removed, the drainage structure could become non functional.
 - b. No maintenance.

Dense growth covering the outlet.

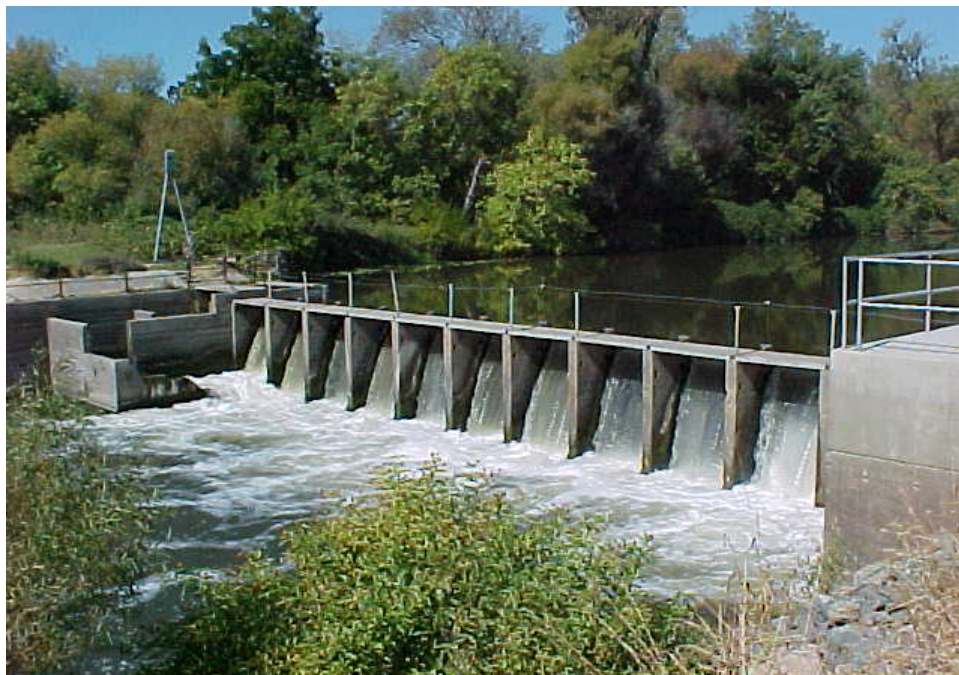
Downstream side of the structure.

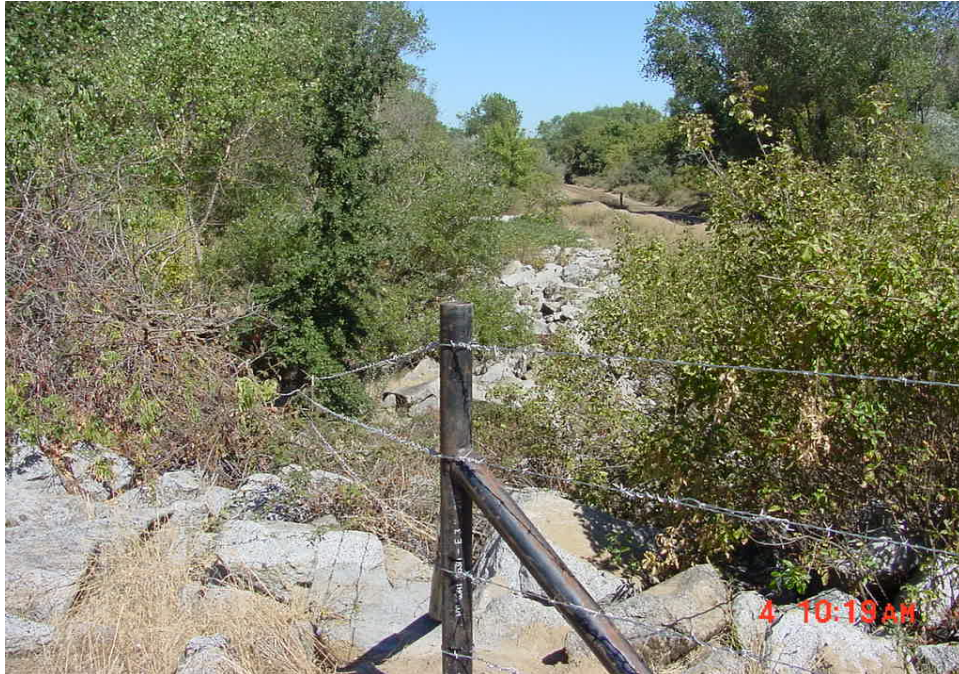
1. Condition of quarry rock weir section.
 - a. Good.
2. Condition of revetments.
 - a. Good.
3. Accumulation of trash and debris around structure or in the channel.
 - a. Areas of debris exist along the weir and in the channel.
4. Vegetation around structure or in the channel.
 - a. Vegetation is very heavy, with trees, brush and berries on the weir section and in the rock revetments.
5. Comments:
 - a. No clearing done since 1985. The vegetation is extremely dense and could impair the functioning of the weir.
 - b. Poor maintenance.
6. Barricade's:
 - a. An unauthorized barricade has been installed at each end of Nelson Bend rock weir, a barbed wire fence runs parallel to the weir from one barricade to the other.

Looking north from the southwest end of the rock weir.

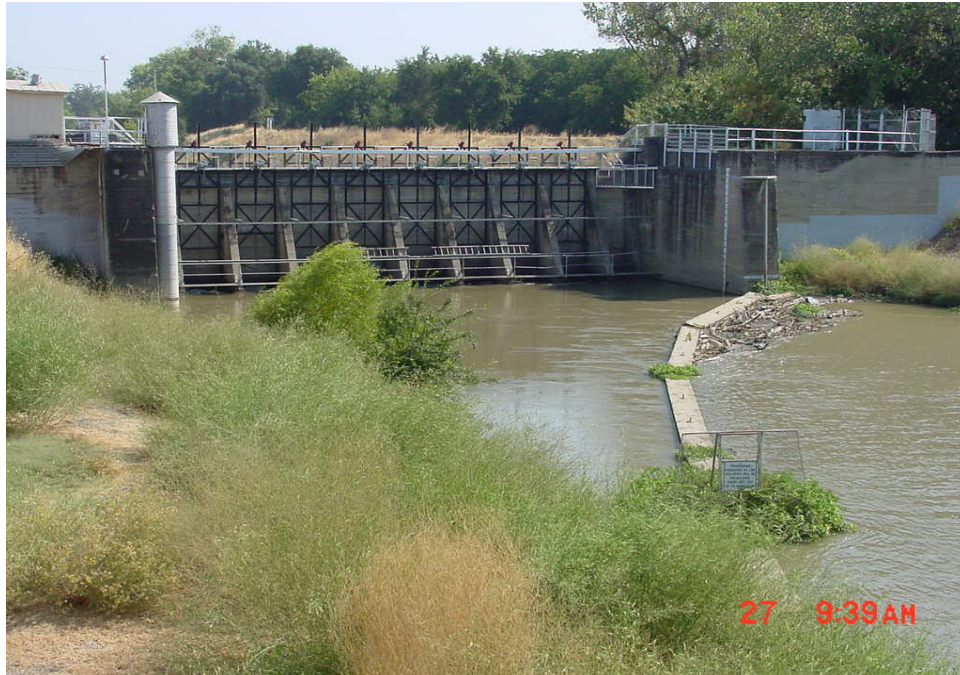
Upstream side of structure from the right bank.

10. Comments:
 - a. Structure is inspected daily.
 - b. The seepage through the structure should be monitored during high water stages.
 - c. Sacramento Maintenance Facility performs a yearly pre-season inspection of the structure and its components before October 15.
 - d. Remove the debris on the right bank upstream of the structure.
 - e. Good maintenance.

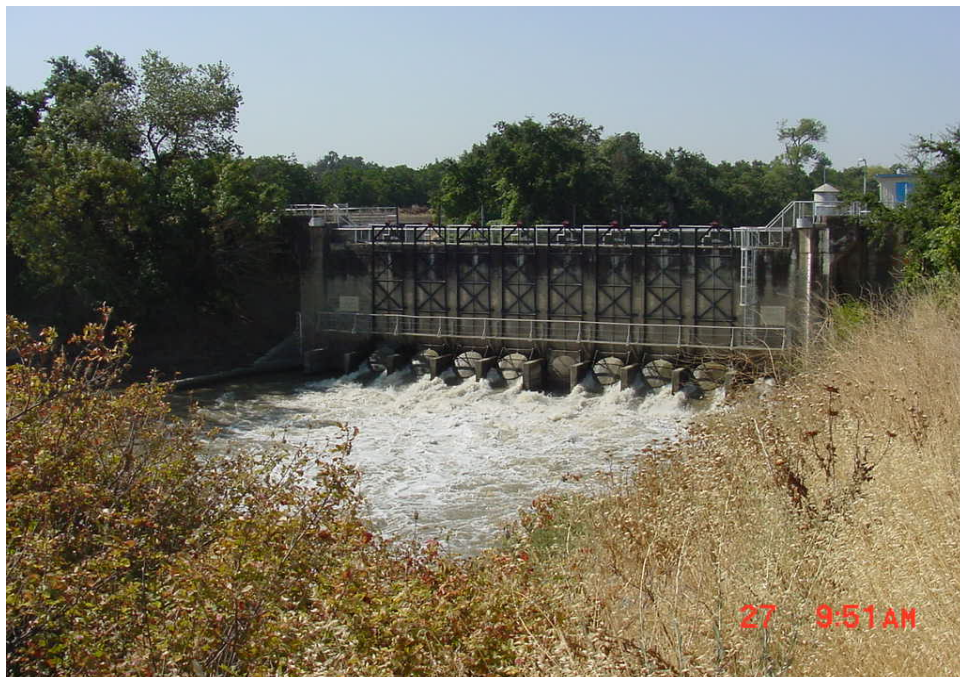
1. Condition of outfall structure.
 - a. Good.
2. Condition of bulkheads.
 - a. Fair. The large vertical crack and displacement on the downstream side, left bank, does not appear to have enlarged. The crack is not accessible for measurement, but the overall width is estimated to be 1 inch.
 - b. The concrete construction joint between the left bulkhead and the outfall structure, upstream side, passes water when the Sacramento River is at high stage. Passage of water was first noticed in 1980.
3. Condition of the pipes.
 - a. Good.
4. Condition of the control gates, mechanisms, and flap gates.
 - a. Good.
5. Condition of electrical equipment.
 - a. Good.
6. Condition of the gauging house and equipment.
 - a. Good.
7. Condition of the log boom.
 - a. Good
8. Condition of fill from bulkheads to levee.
 - a. Good.

Downstream side of the structure from the right bank.

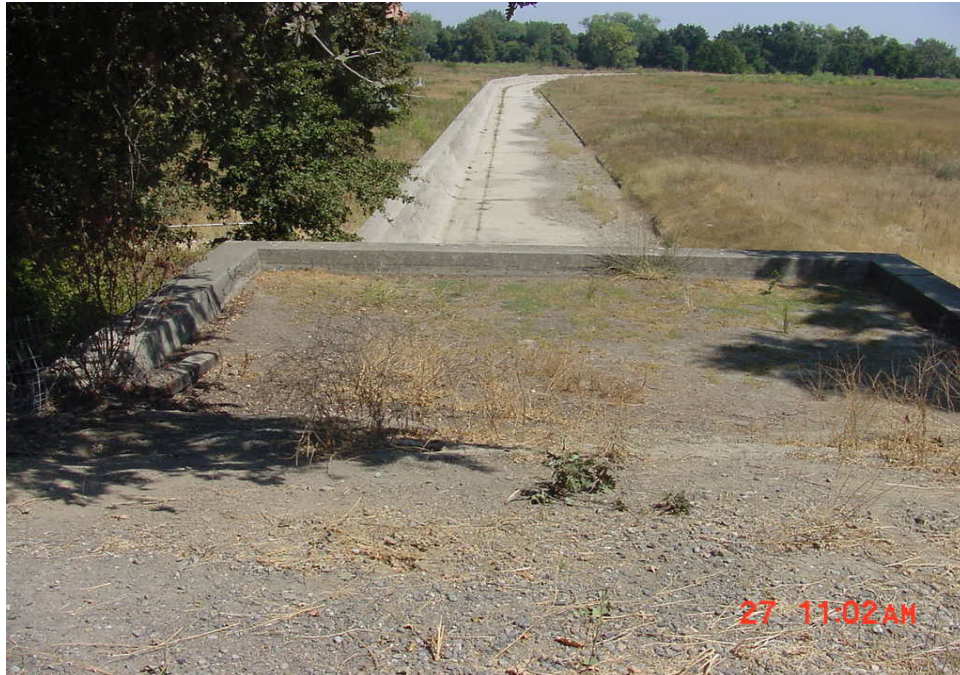
- 1. Condition of concrete weir and stilling basin.**
 - a. Some cracks and spalling exist on the weir and in the stilling basin.**
- 2. Condition of concrete abutment.**
 - a. Good.**
 - b. The crack on the downstream side of the right (west) abutment, and the two cracks on the right abutment at Rattlesnake Island, have not enlarged.**
- 3. Condition of revetment.**
 - a. Good.**
- 4. Accumulation of trash and debris around the structure or in the channel.**
 - a. Minimal.**
- 5. Vegetation around the structure or in the channel.**
 - a. Minimal.**
 - b. Minimal.**
- 6. Condition of gauging house and equipment.**
 - a. Good.**
- 7. Comments:**
 - a. Monitor the cracks and spalling and repair as needed.**
 - b. Remove debris from the stilling basin prior to flood season.**
 - c. Good maintenance.**

View of weir and stilling basin from the north abutment.

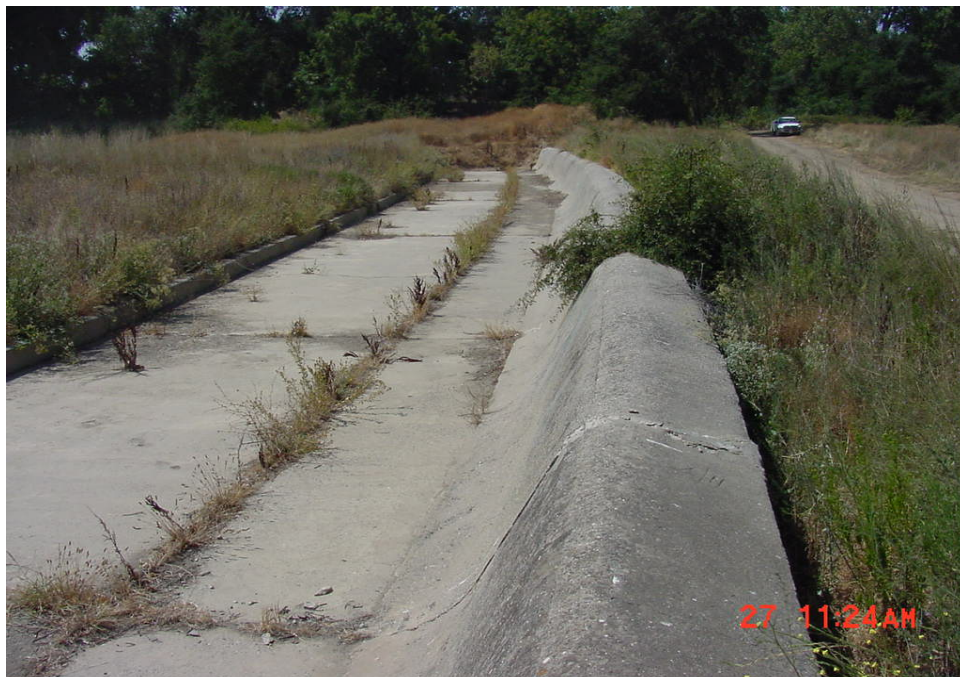
Looking towards Rattlesnake Island.

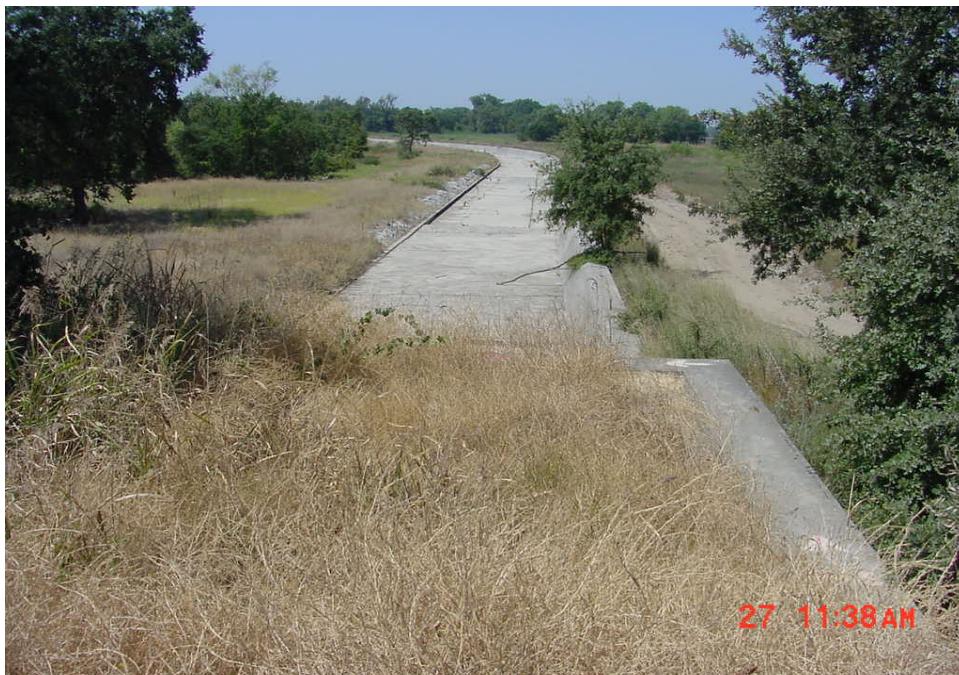
Looking northwest from the southern abutment.

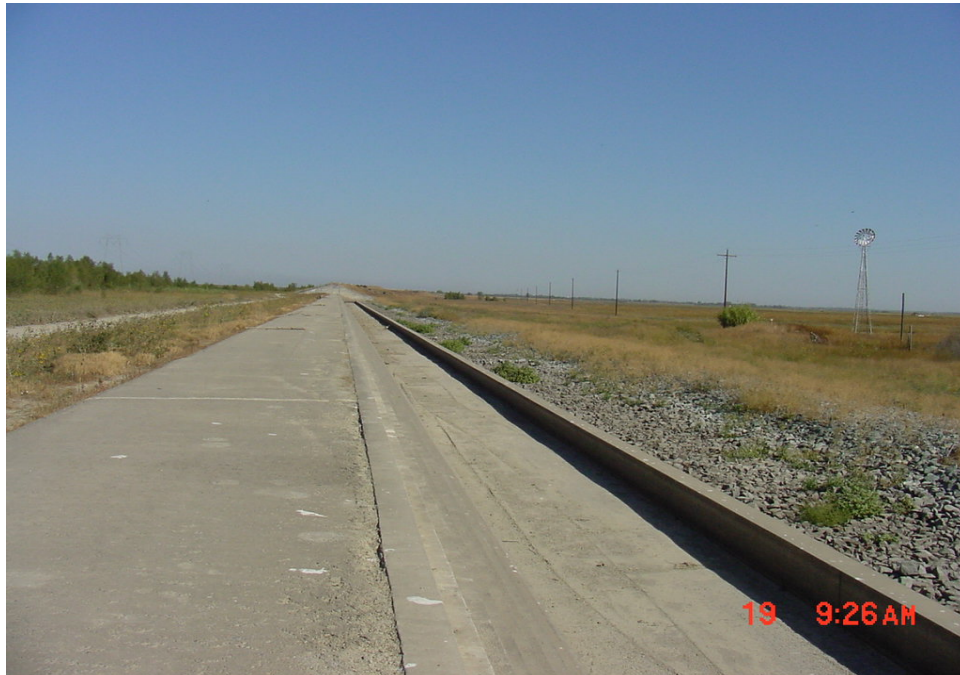
Looking northeast at the weir and settling basin.

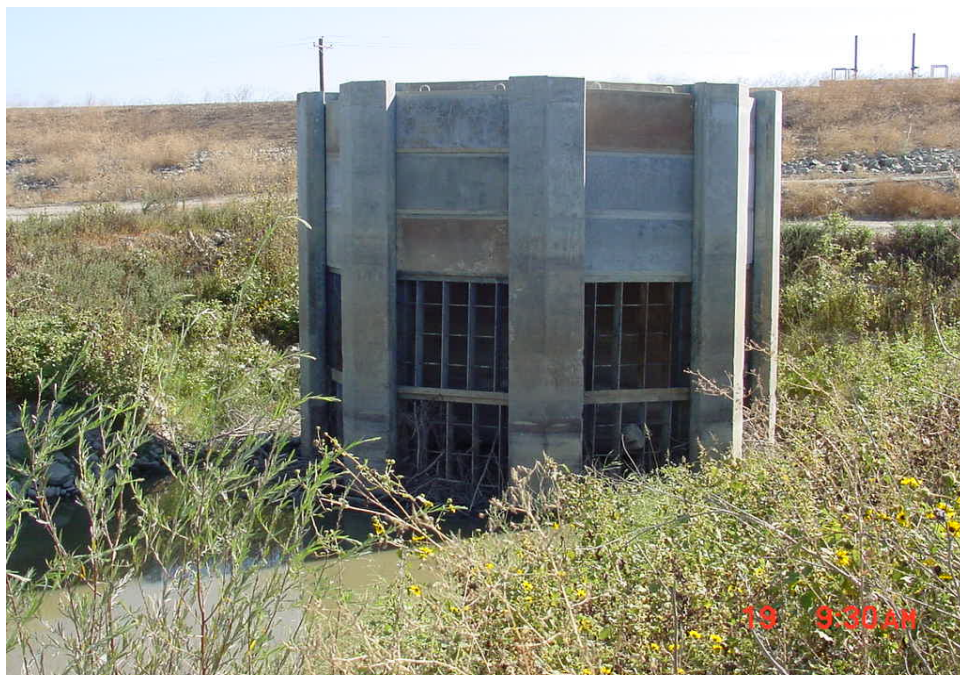
View of the drainage structure.

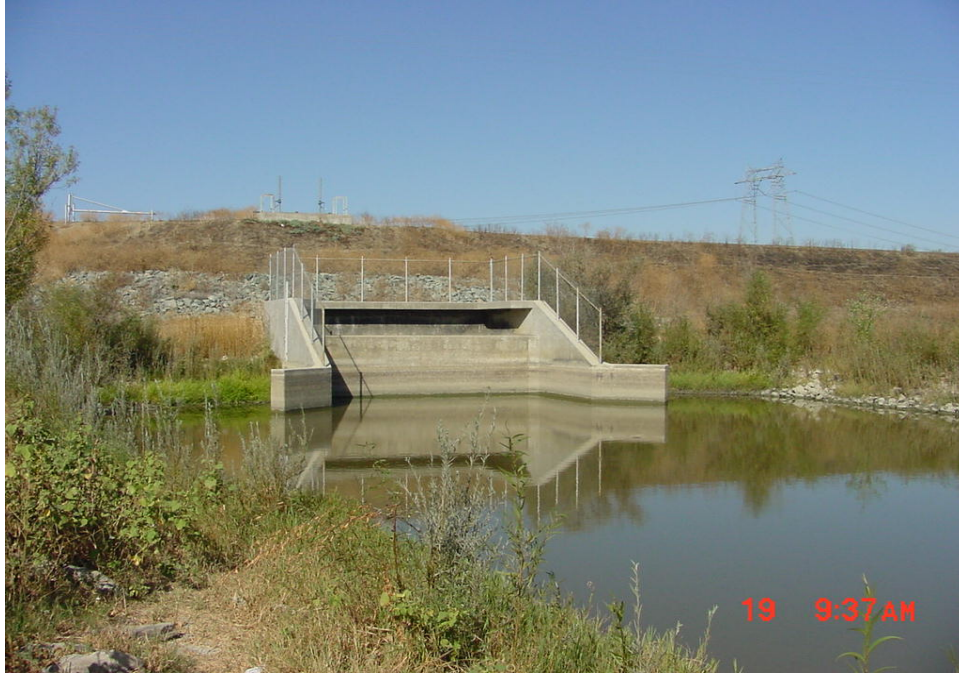
Outlet for the drainage structure.

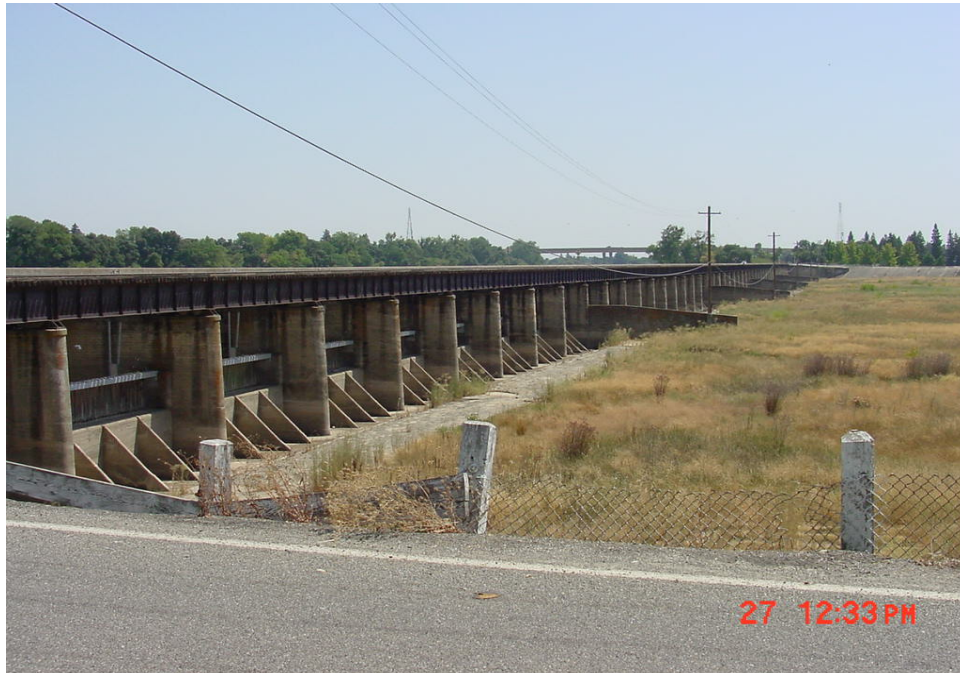
Outlet side of weir from the north end.

- a. A final pre-season operational inspection is scheduled for the week of October 1-10 by the Sacramento Maintenance Facility.**
- b. Remove the growth, trash, and debris from around the structure.**
- c. Good maintenance.**

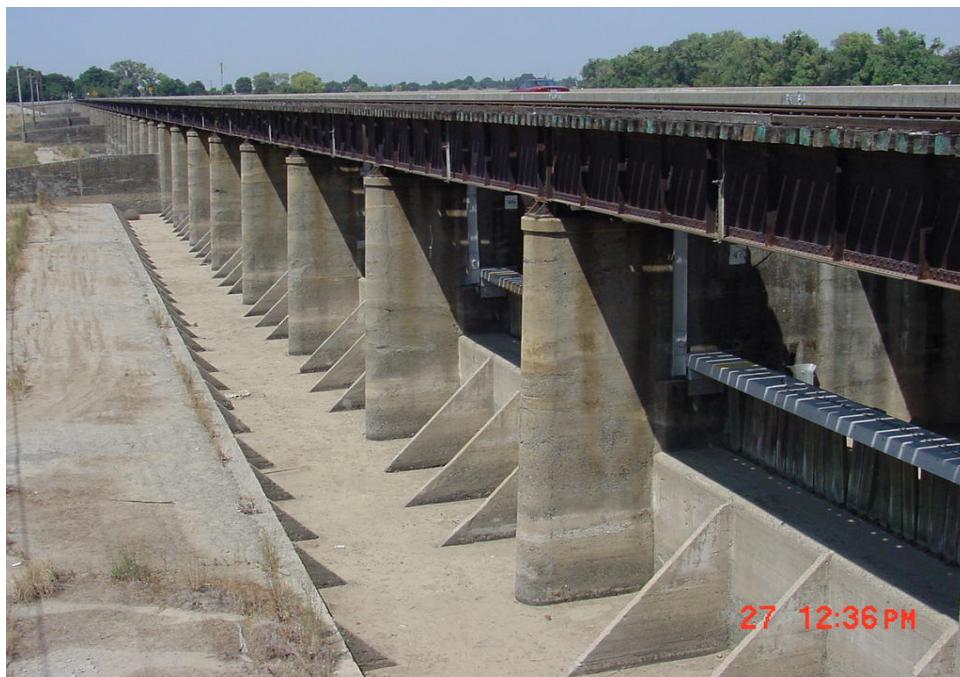
Outlet side of weir from the south end.

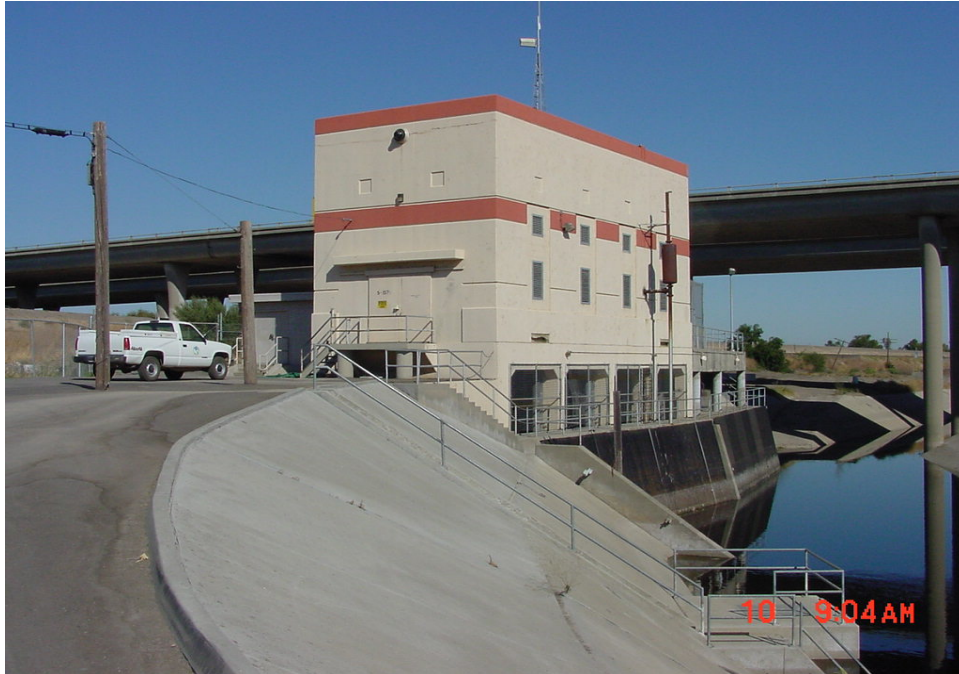
Pumping plant, sump, and trash racks at inlet side on the landward side from the left bank levee of the Natomas East Main Drain.

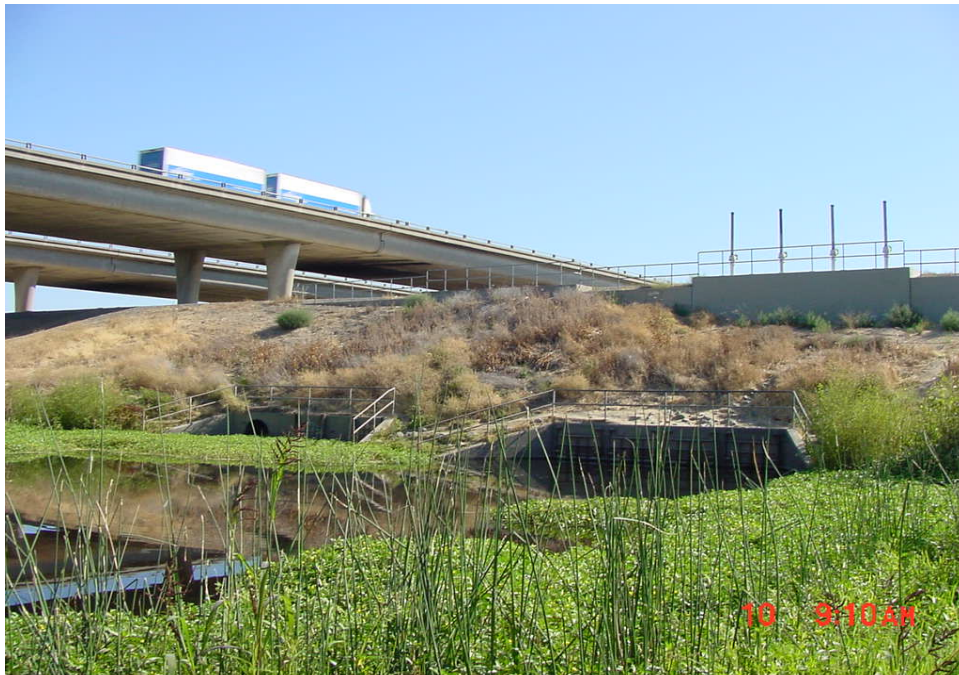
Discharge end of structure on the water ward side from the left bank levee of the Natomas East Side Drain.

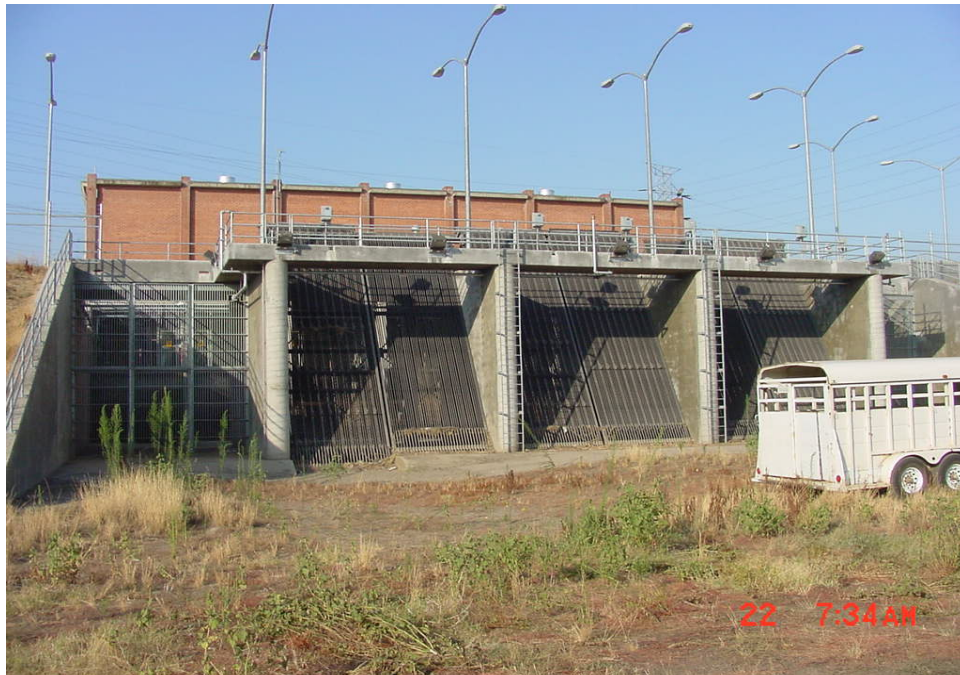
Pumping plant, sump and trash racks at inlet on the landward side of the right bank levee of the American River.

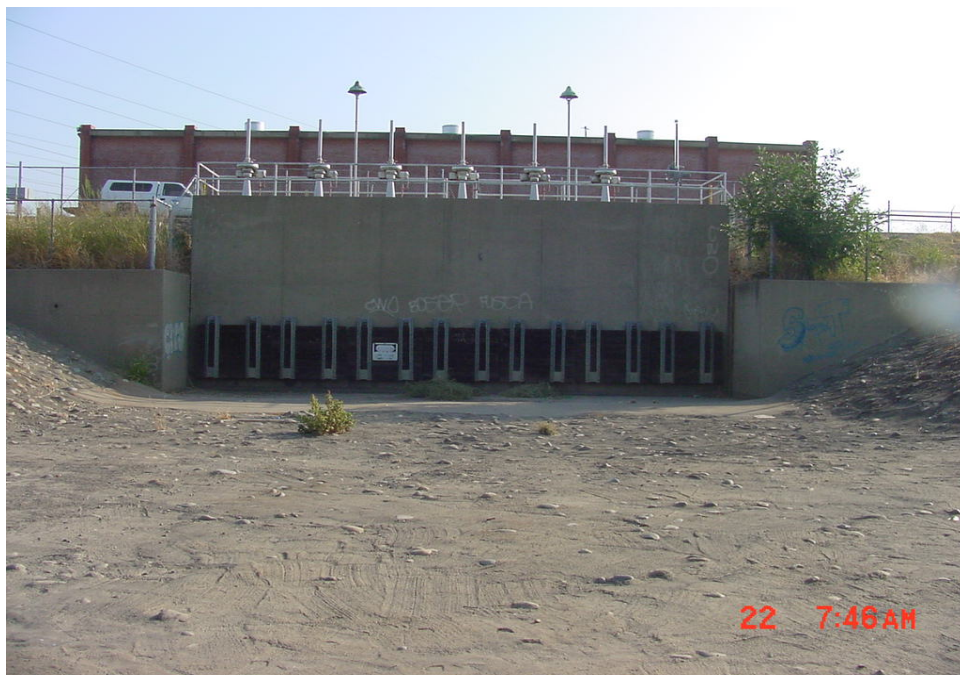
Gate controls and gates at the discharge side of the pumping plant.

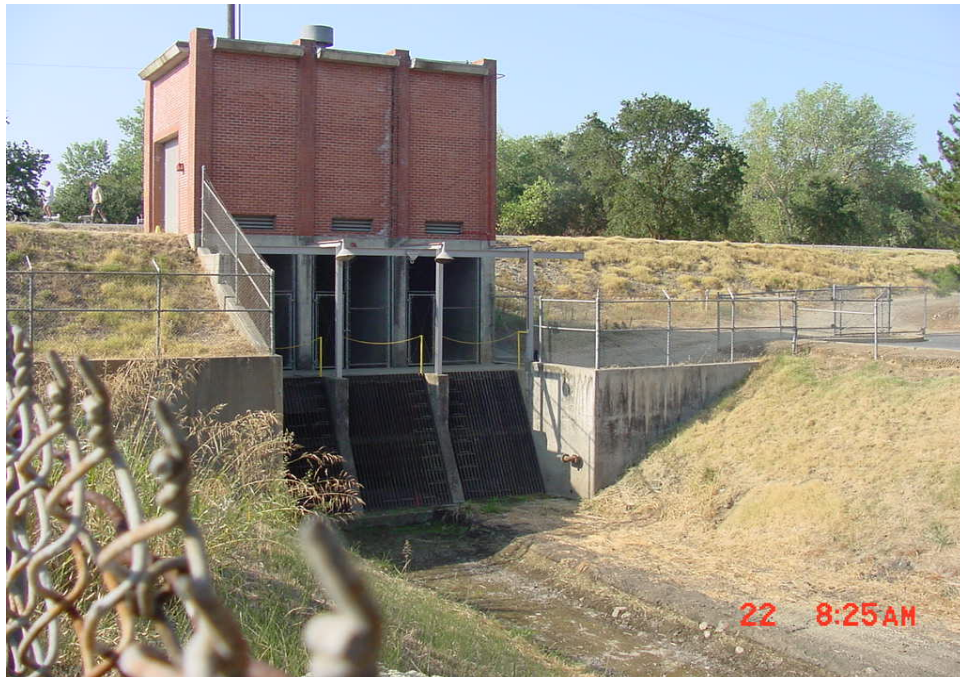
Trash racks on the intake side of the pumping plant.

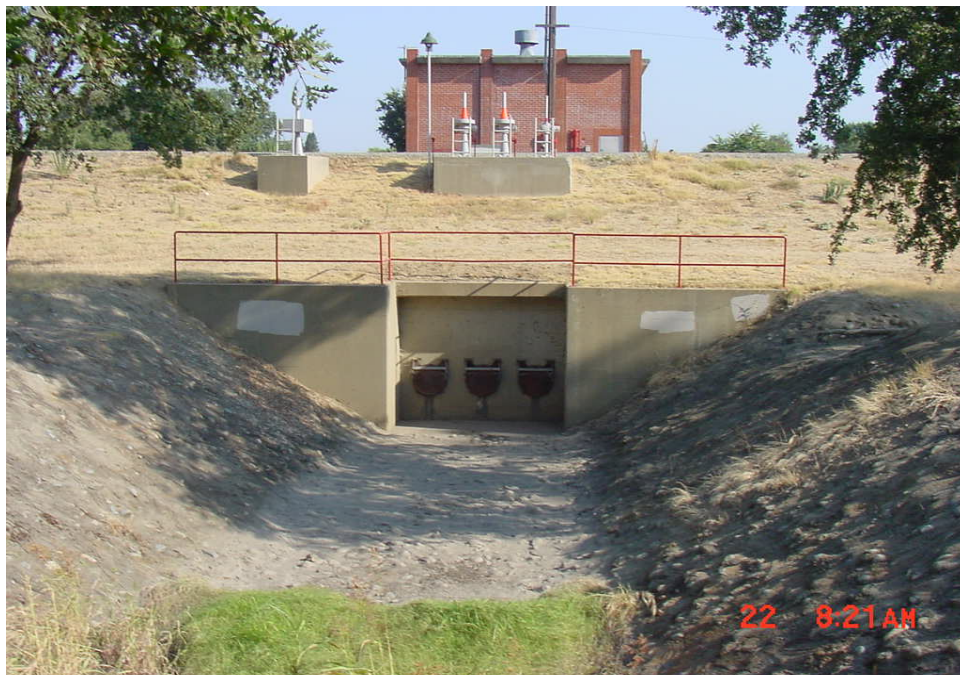
**Gate controls and flap gates on the
discharge side of the pumping plant.**

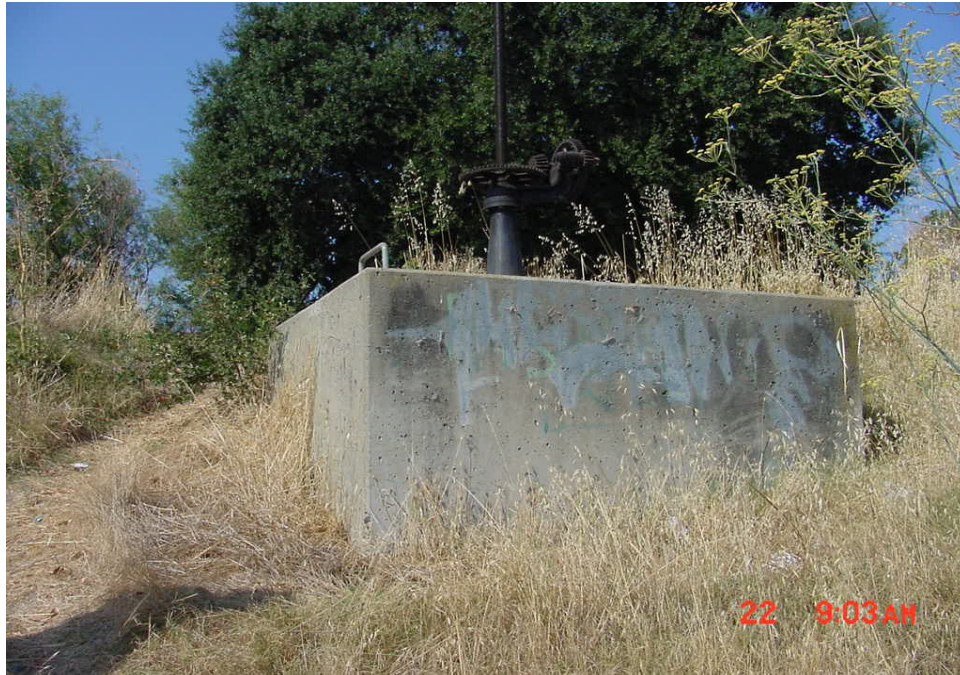
View of the gate control mechanism box.

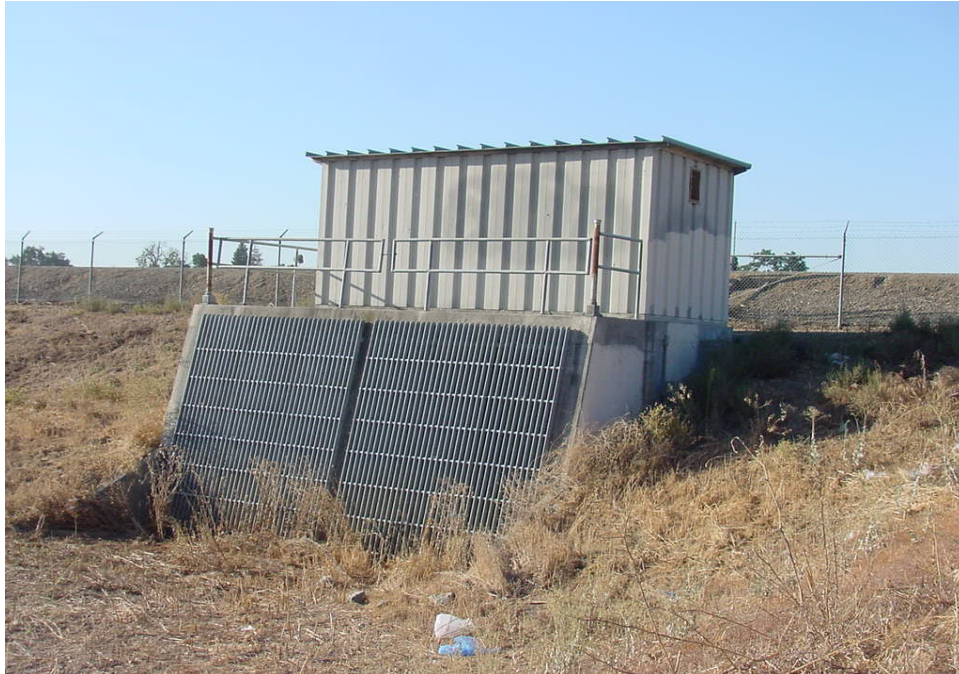
Trash racks on the intake side of the pumping plant.

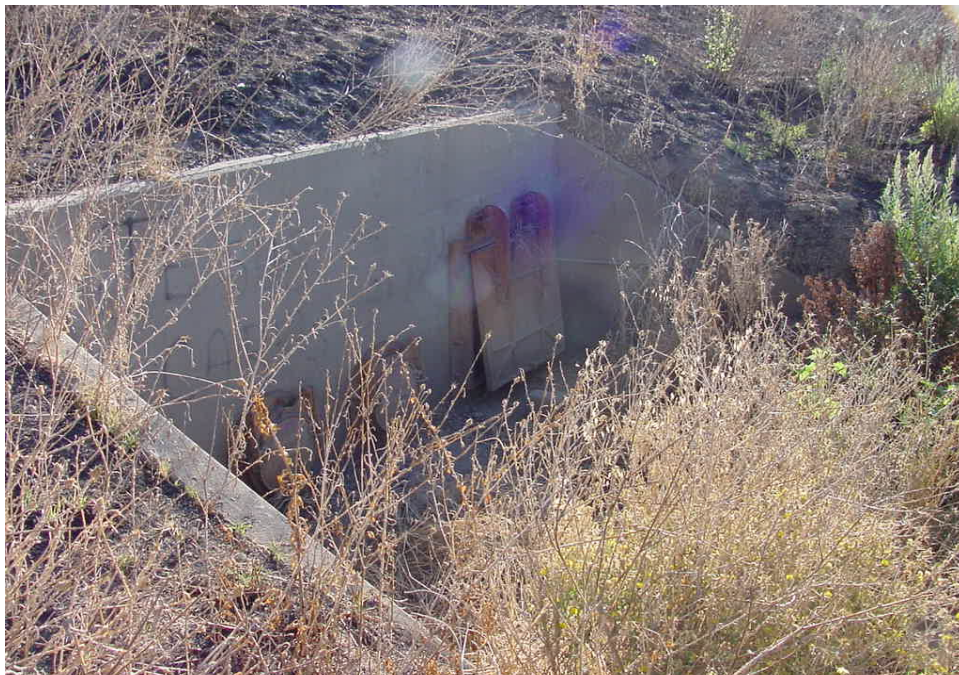
**Flood wall, screw gate and
the outlet side of the pumping plant.**

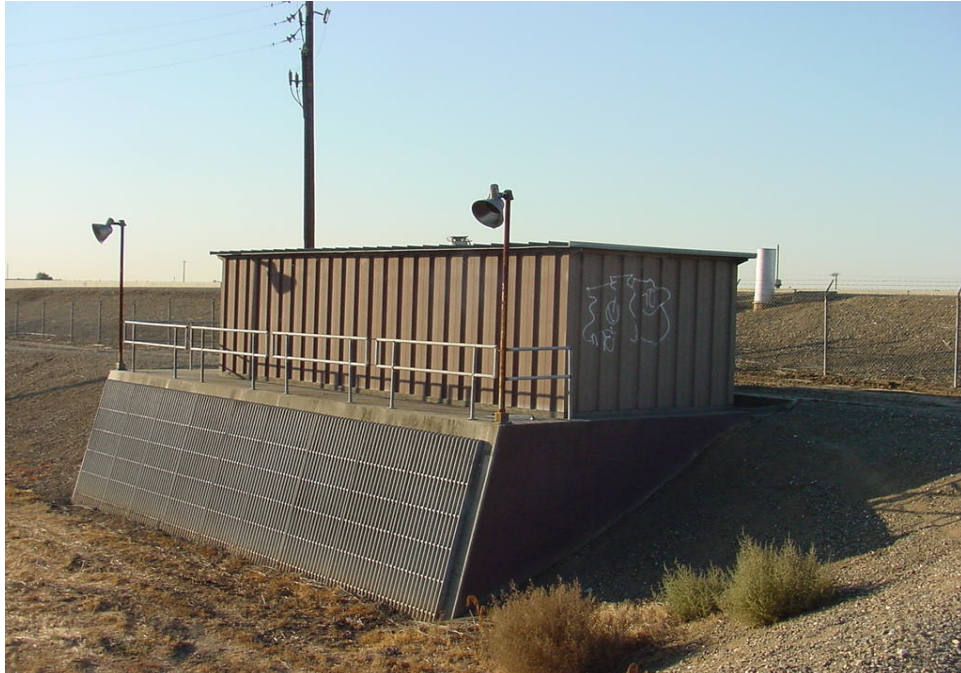
Inlet side of the pumping plant.

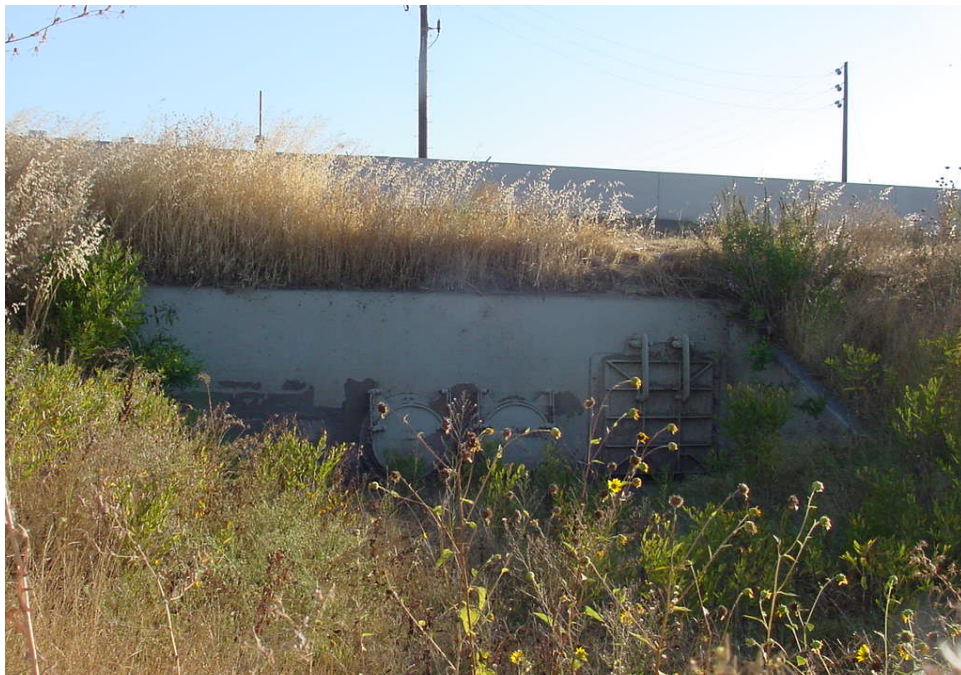
Outlet side of the pumping plant.

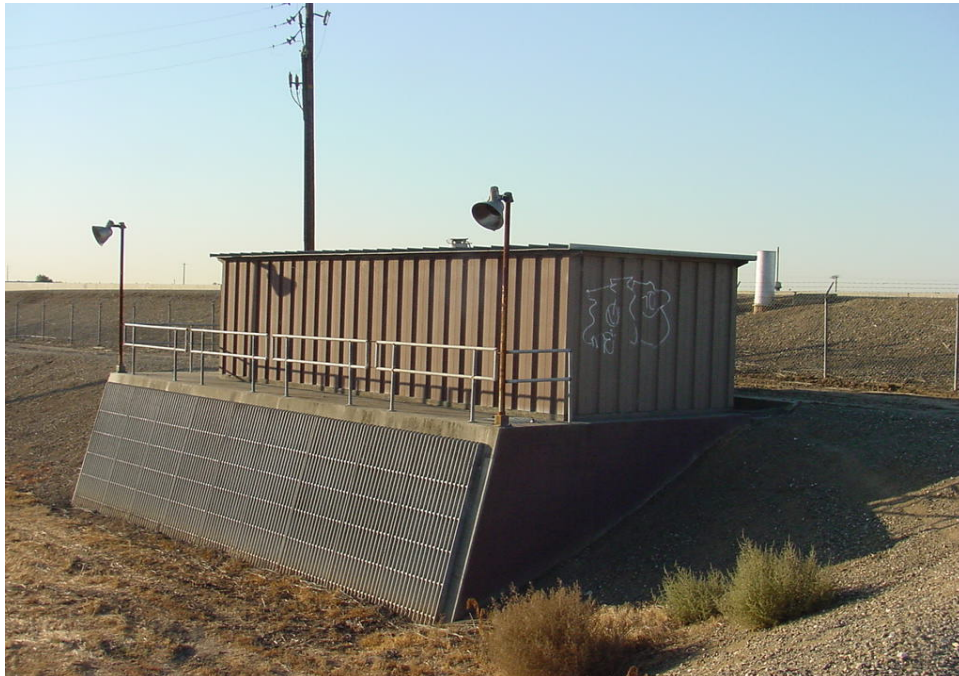
Inlet side of the pumping plant.

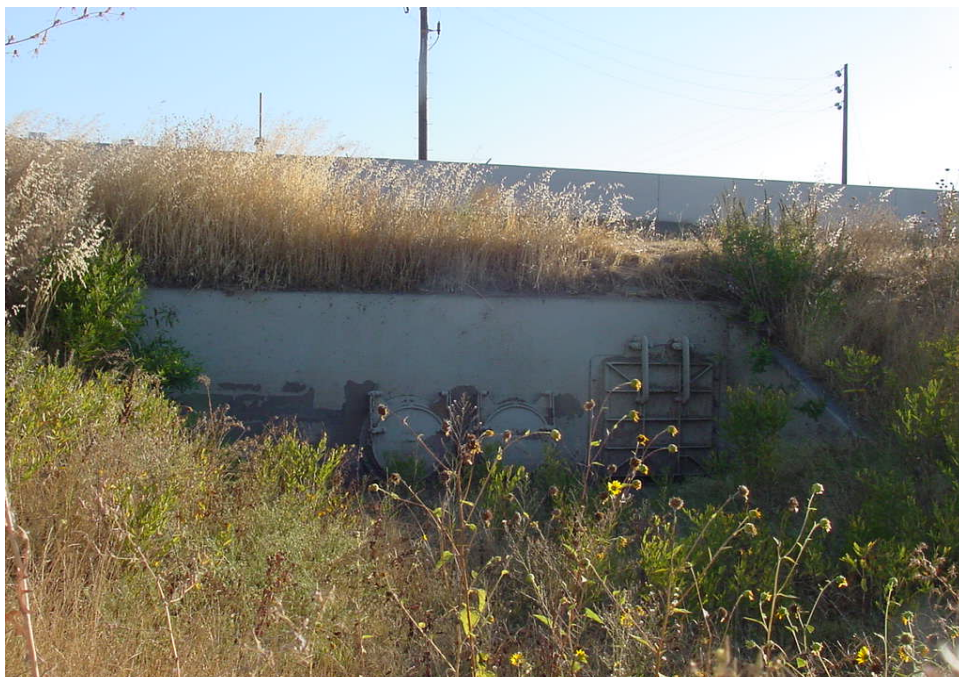
Flood wall, screw gate and outlet side of the pumping plant.

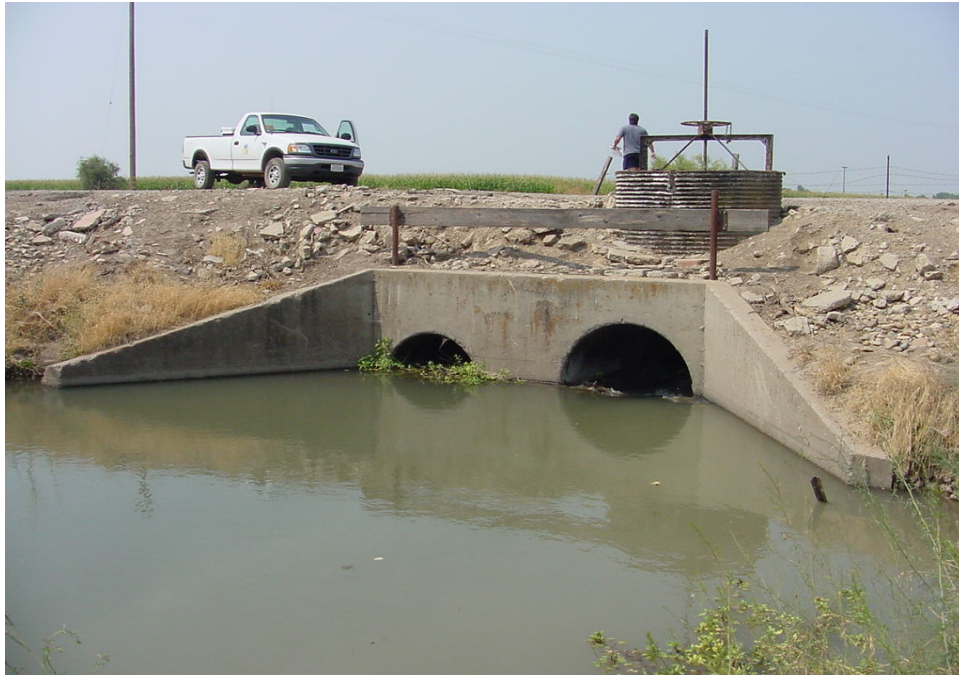
Inlet side of control structure.
